2. WAG 1, TEST AREA NORTH

3. WAG 2, TEST REACTOR AREA^a

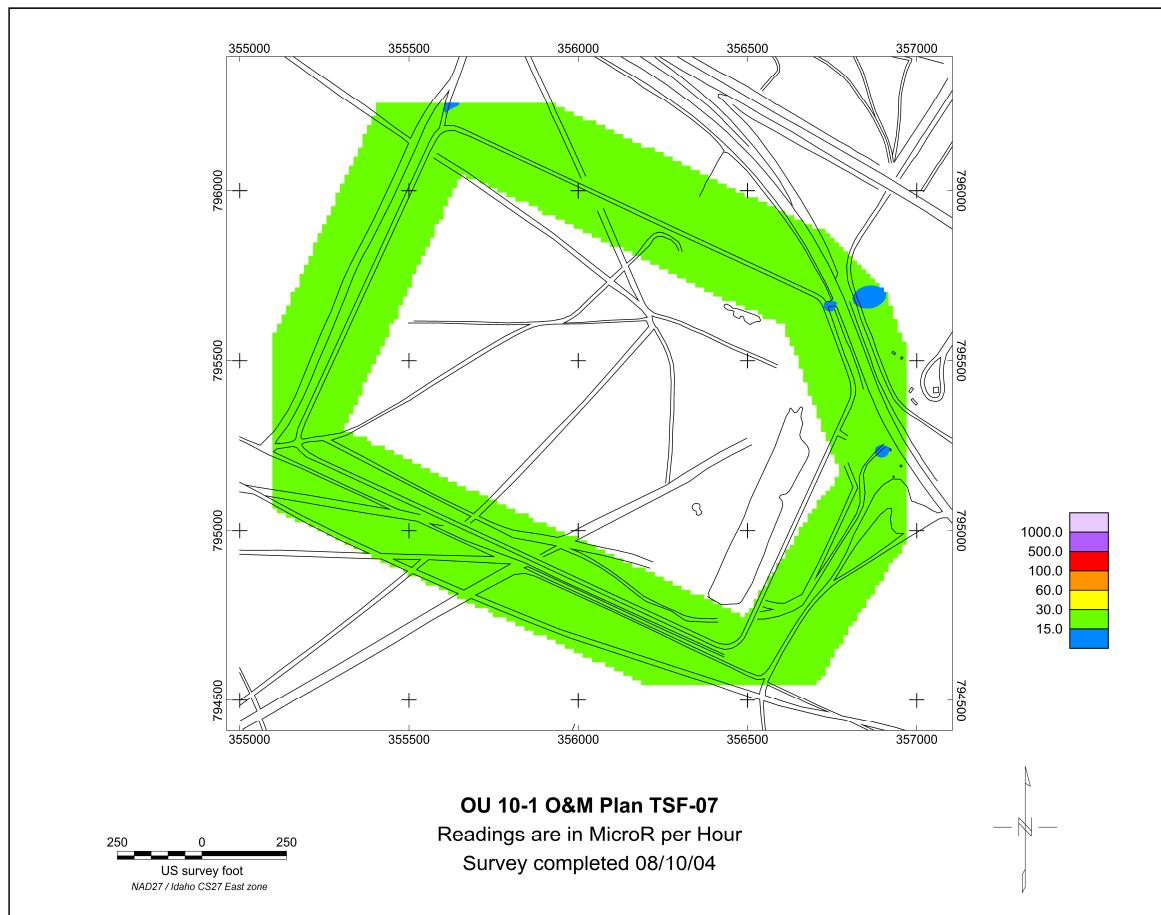
In past years, radiological surveys have been performed at TSF-07, TSF-26, TSF-09, TSF-06 Area B, and TSF-18 to monitor for windblown contamination. In 2004, the surveys could only be performed at TSF-07. The other sites were inaccessible to the vehicle-based (Humvee) global positioning radiometric scanner (GPRS) equipment due to remediation work. Results of the August 10, 2004, environmental monitoring radiation survey are shown in Figure 2 and Table 1. Note that the detector configuration changed in November 2003. The conversion factor for changing counts to exposure rates came out about double the previous one. The net count rate from 2003 to 2004 is statistically the same. The perimeter of TSF-07 read basically background levels, and no change from previous years was noted. Refer to Figure 3 for the log record of the O&M inspection activity.

Figure 2. Results of in situ gamma scan at the perimeter of TSF-07.

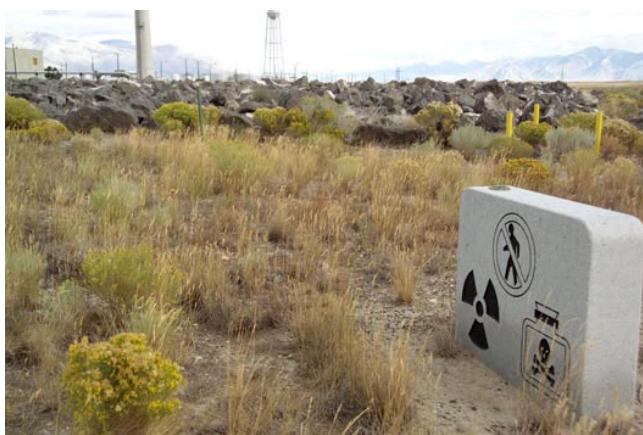
Figure 5. TRA-03 warm waste pond monument.
PD040213-15.jpg

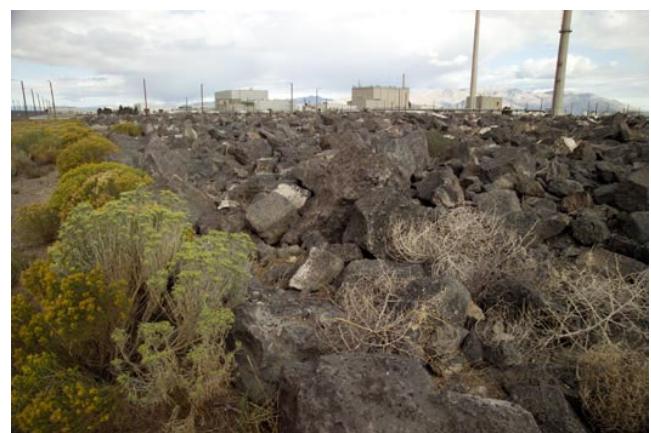
Figure 6. TRA-03 warm waste pond riprap cover.
PD040213-16.jpg

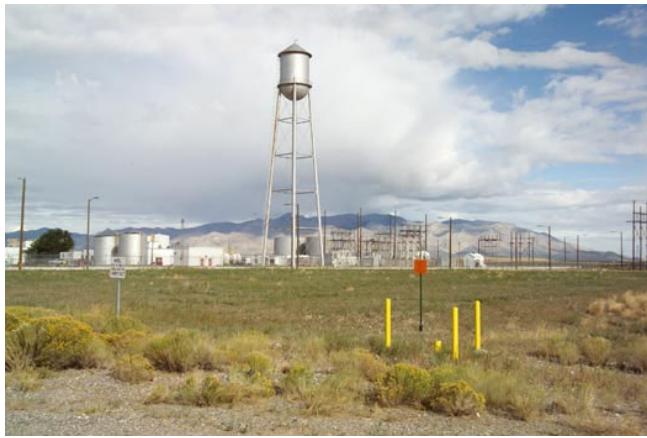
Figure 7. TRA-13 sewage leach pond. PD040213-24.jpg

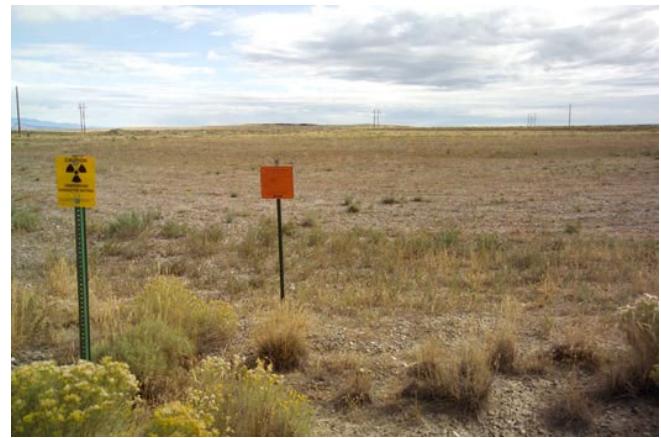
Figure 8. TRA-13 sewage leach pond warning signs. PD040213-22.jpg

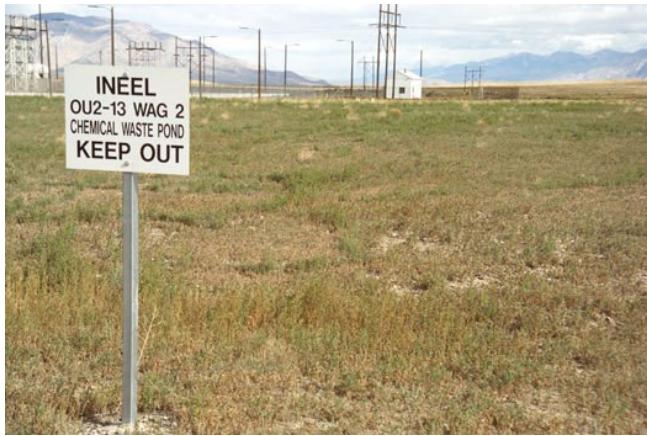
Figure 9. TRA-06 chemical waste pond. PD040213-26.jpg

The 2004 inspection indicated no change from the previous annual inspection. No evidence of subsidence or erosion was noted. Vegetation was sparse on TRA-06 and TRA-13, with weed growth noted. No evidence of animal intrusion was observed.

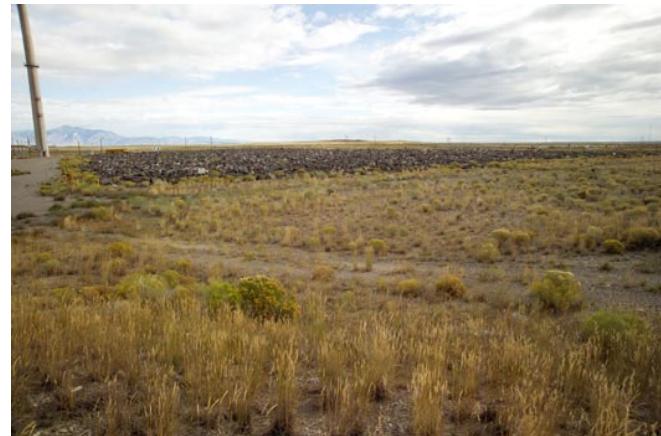
Figure 10. Vegetation around TRA-03. PD040213-19.jpg

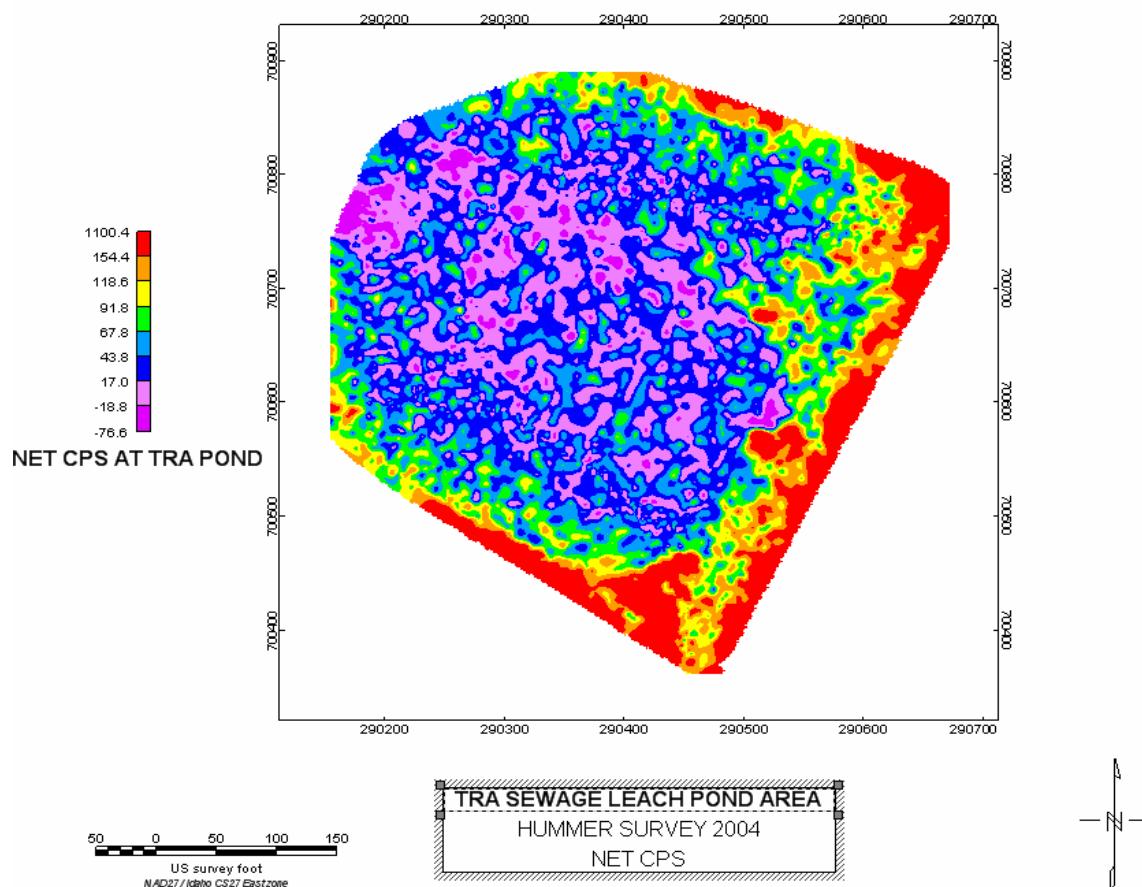
The results of the GPRS survey of the sewage leach pond area, TRA-13, and the TRA-13 SCA are shown in Figure 11. There is a slightly elevated exposure rate along the south, east, and north perimeters of the cover. This is consistent with the results of surveys in previous years and does not indicate migration of contamination.

Figure 11. Humvee drive-over survey at the TRA sewage leach pond in 2004.

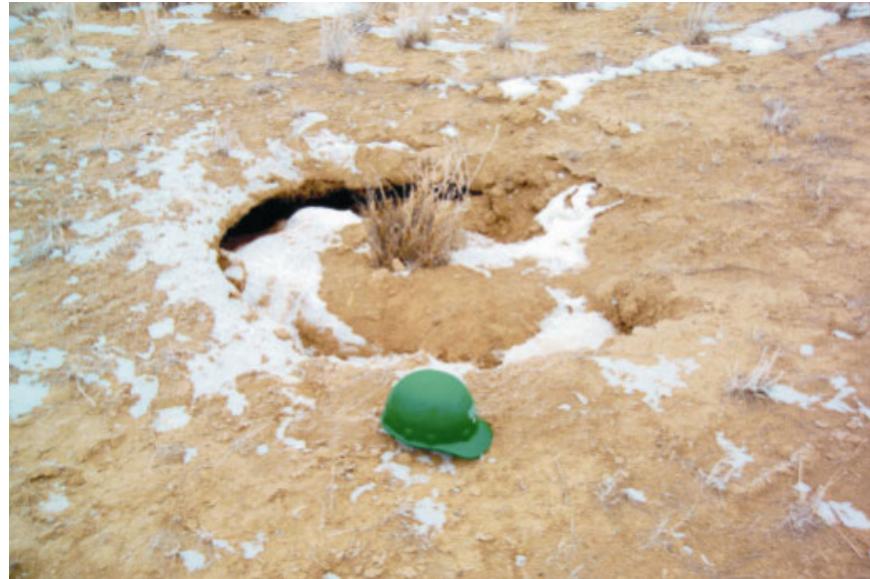
The 2004 O&M inspection showed that the remedies at WAG 4 are performing as designed. With one exception, there was no visual evidence of subsidence, erosion, or intrusion. Settling at Landfill III, however, has resulted in slumping in one area. The area, which was small at the time of the April 2004 inspection, showed increased subsidence when visited later. In November 2004, the area was approximately 3 ft across, as shown in Figure 13. Repair of the subsidence is scheduled for the 2005 construction season.

Figure 13. Area of subsidence on CFA Landfill III in during winter of 2004.

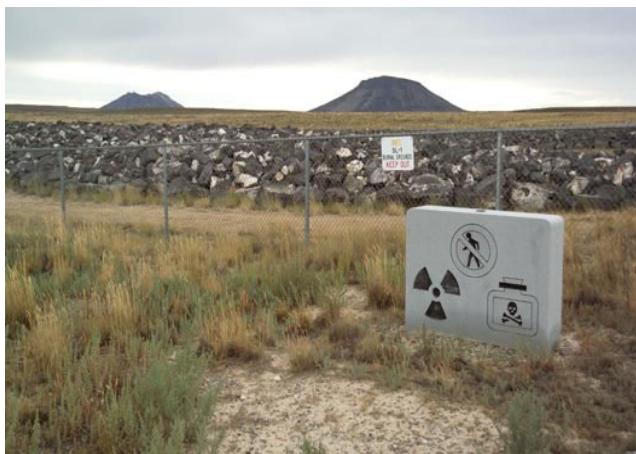
Figure 15. SL-1 monument. PD040213-01.jpg

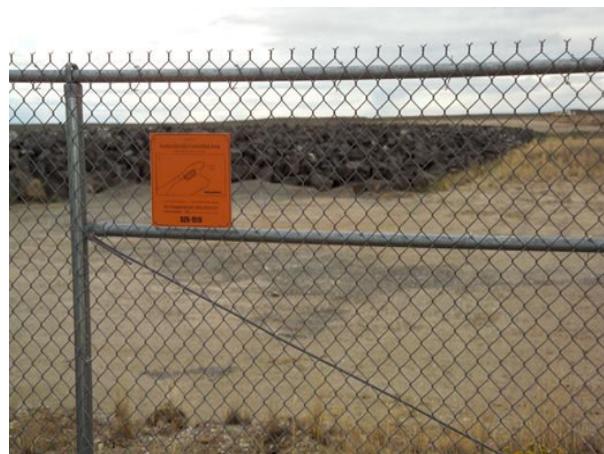
Figure 16. SL-1 CERCLA sign. PD040213-11.jpg

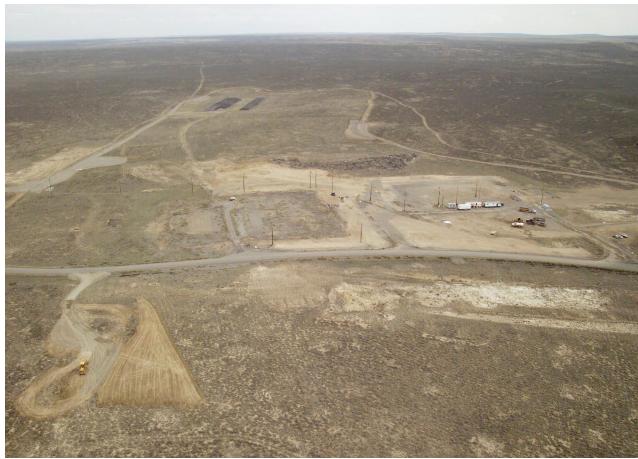
Figure 17. Aerial view of WAG 5.
PD040079-130.jpg

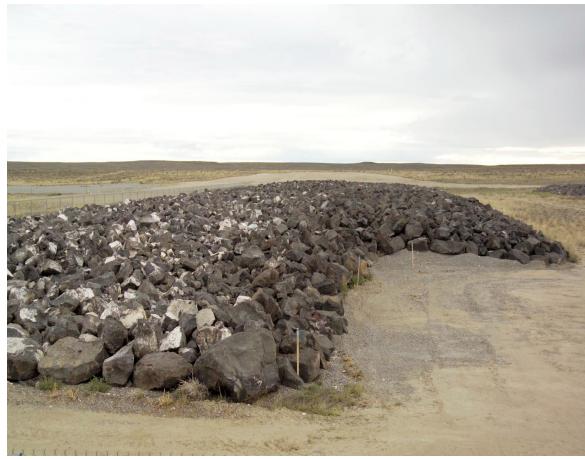
The biotic barrier and riprap at ARA-06 were evaluated visually for erosion, animal intrusion, and settling of the cover, with no findings noted. A radiological survey of the ARA-06 site perimeter was also performed; the results indicated no change in conditions from previous years.

Figure 18. North trench of the SL-1 burial ground.
PD040212-10.jpg
